RESERVOIRS

The chapter on Masonry Dams has been increased twofold by an attempt to make some mention of all the most notable dams of the world, and many that are very little known. Attention is particularly directed to Plates 1, 2, and 3, in which profiles are shown of all of the leading and better known masonry dams in existence, drawn to uniform scale for easy graphical comparison. No such complete collection of dam profiles has ever before appeared in print, assembled together on a common basis.

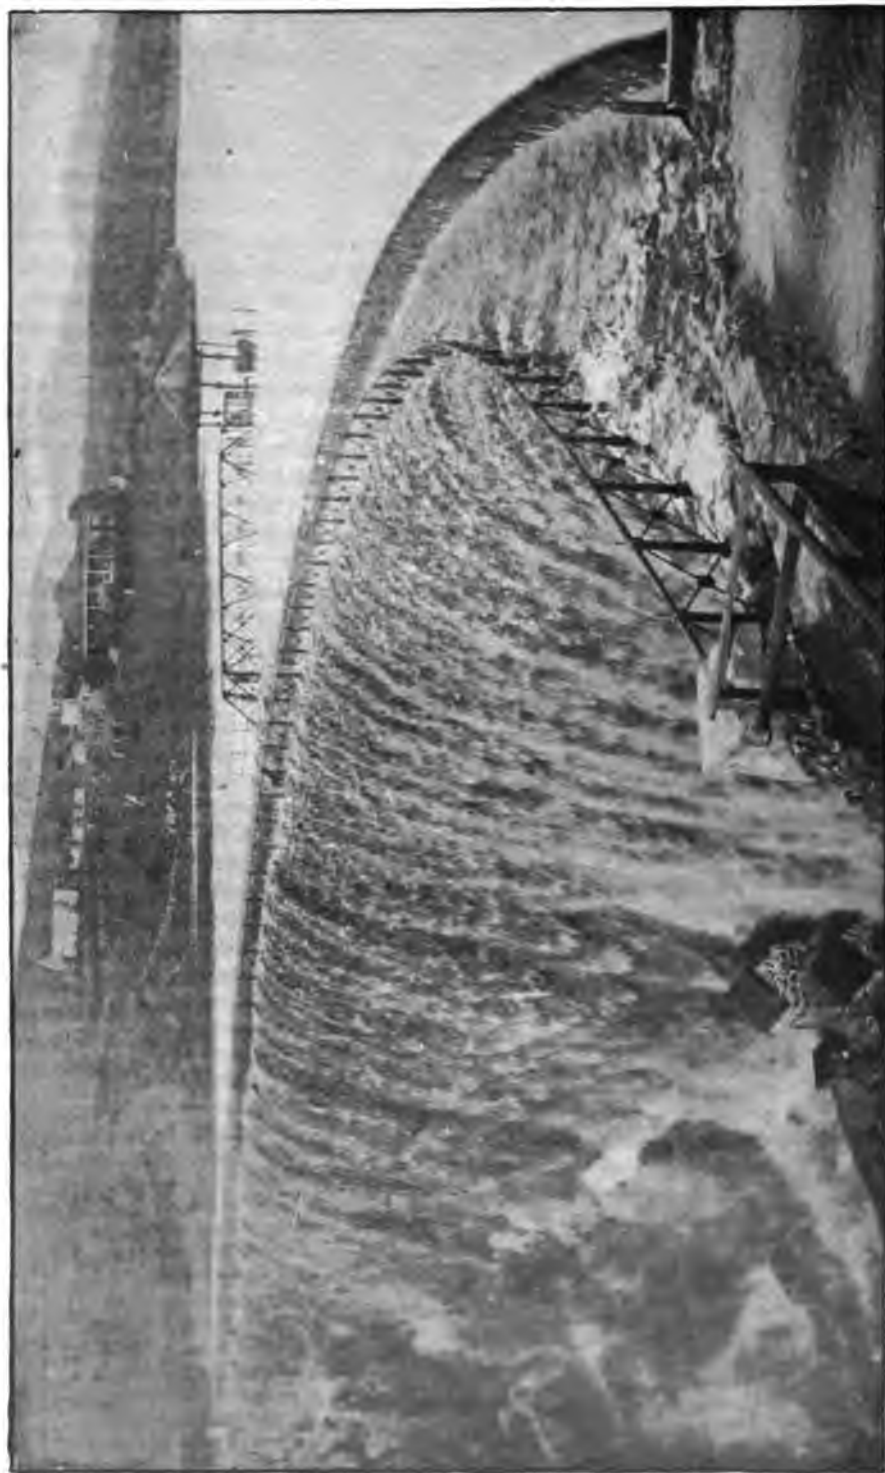
FIG. 155.—SWEETWATER DAM DURING THE GREAT FLOOD OF JANUARY 17, 1895.

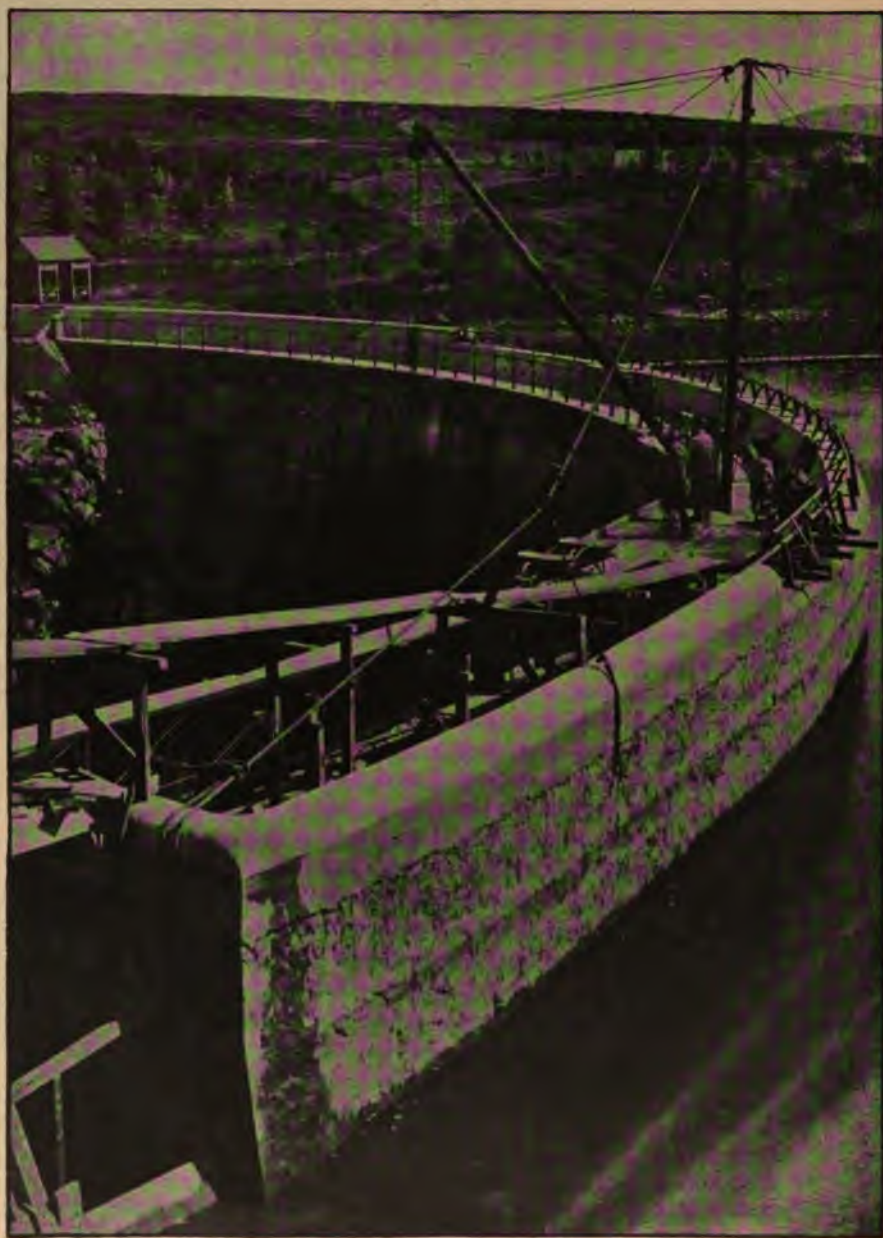
FIG. 159.—REPAIRING AND INCREASING THE HEIGHT OF THE PARAPET OF SWEET-WATER DAM.

1. The parapet of the dam was raised 2 feet and strengthened, so as to permit of permanently holding the water in the reservoir as high as its crest, leaving 200 feet in the center as a weir, 2 feet deep. This weir was arranged with cast-iron frames carrying flashboards, to be removed in extreme floods, as shown in Fig. 157.

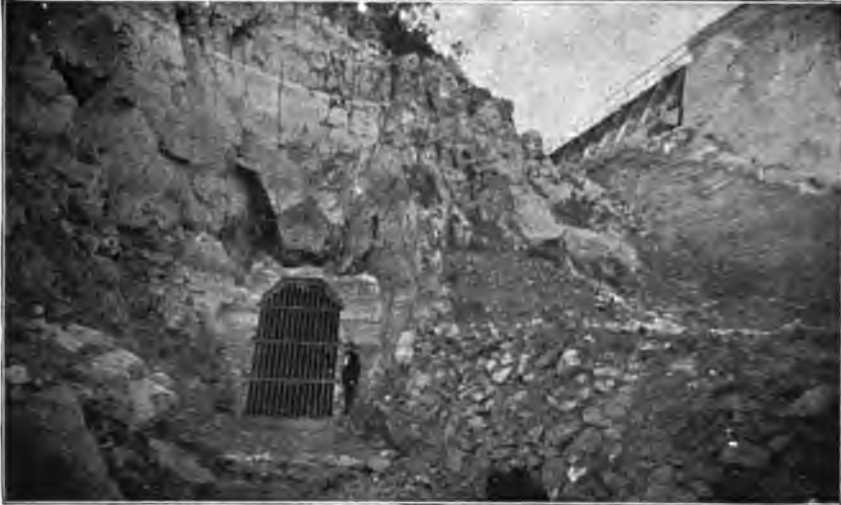
FIG. 163.—SWEETWATER DAM, SHOWING HEAD OF OUTLET TUNNEL AND SPILLWAY.

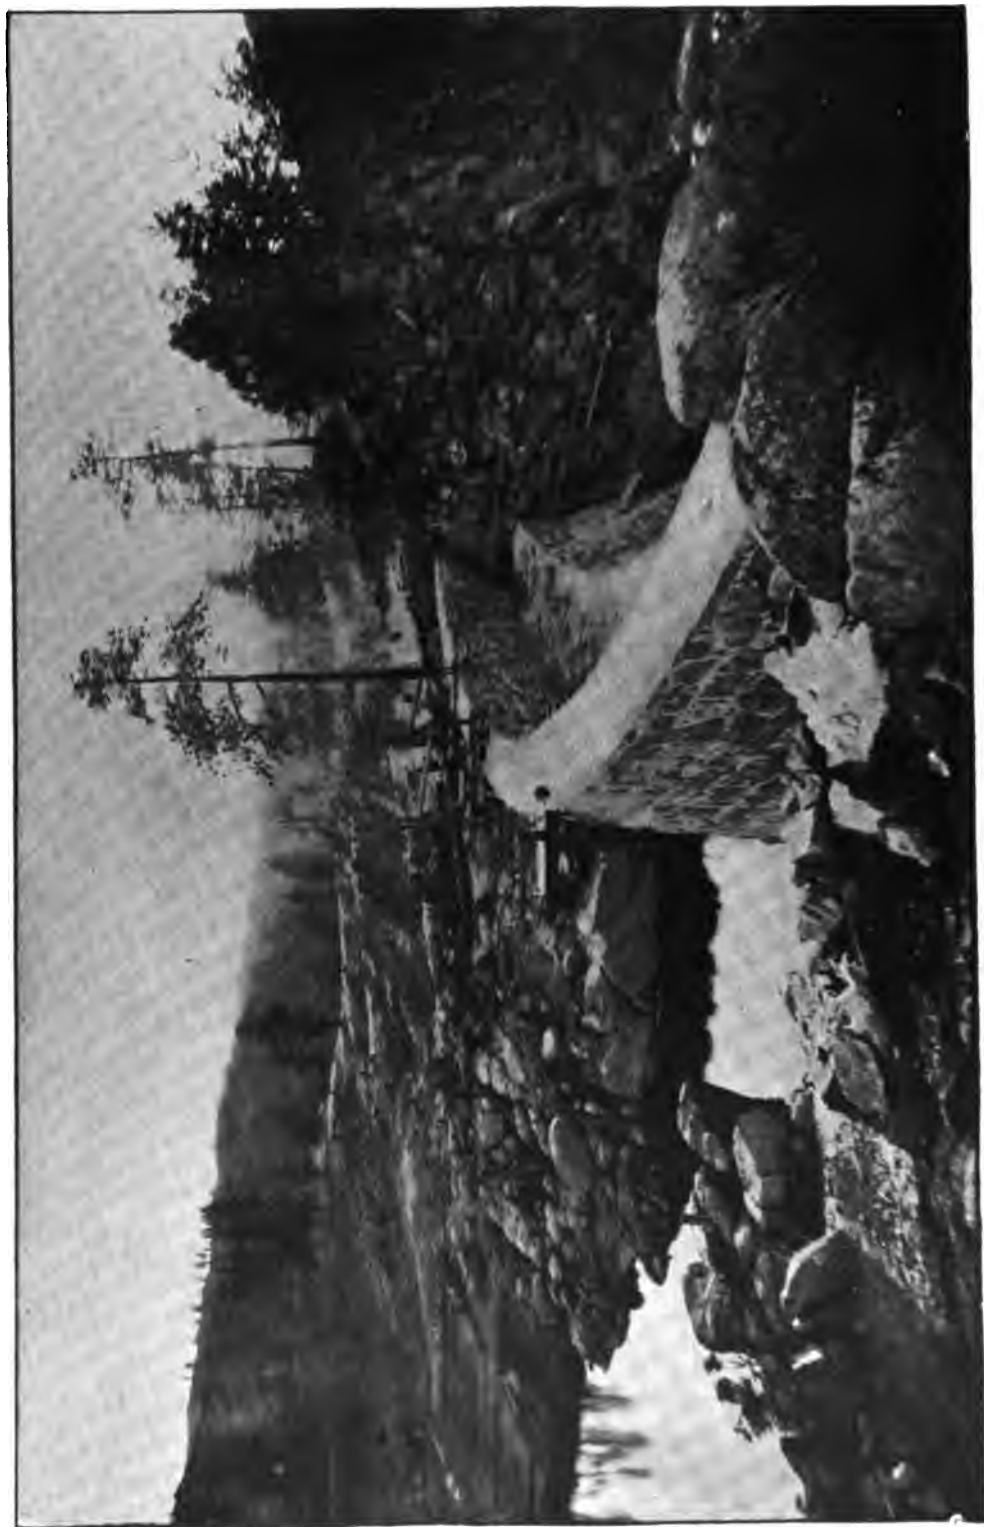
FIG. 167.—HEMET DAM AS FINISHED, SHOWING THE SPILLWAY RIDGE SOUTH OF THE DAM.

has thus far been erected in western America for irrigation-storage is the dam erected in the San Jacinto Mountains, in Riverside County, California, at the outlet of Hemet Valley, the location of which with respect to the irrigated lands is shown in Fig. 165. The view in Fig. 166 is rather an imperfect representation of the appearance of the dam from below. Fig. 167 is an end view which shows the arched form of the dam.

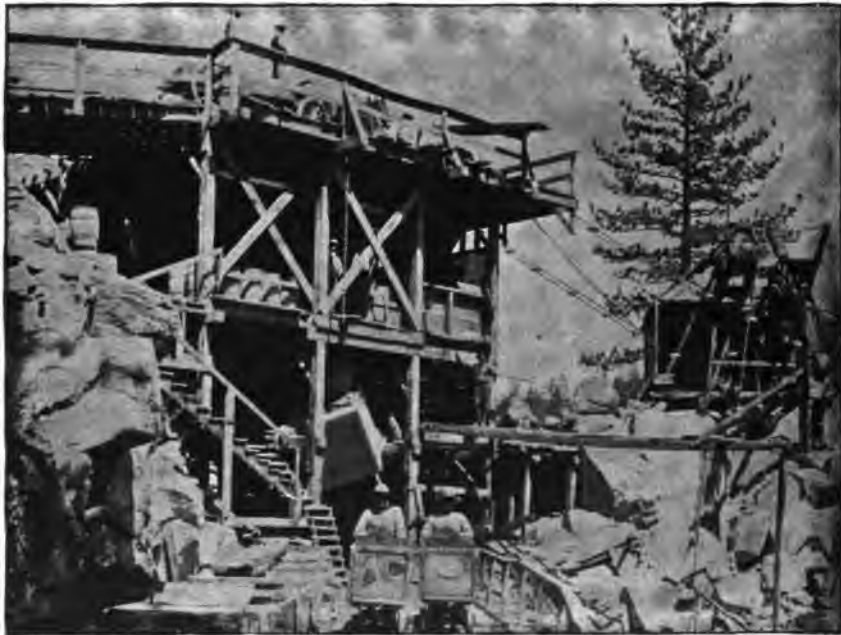
FIG. 170.—HEMET DAM CONSTRUCTION PLANT.

170 shows a view of the plant for crushing the stone and mixing the concrete. A portion of the sand-conveyor is also visible in the photograph, as well as one of the engines used on the cableways, and the cars for the

delivery of concrete to the dam. These latter ran along a tramway, laid on a trestle built from the mixing-platform along the face of the vertical cliff, some 300 feet, to the dam at the 80-foot level. When the dam reached this level an elevator was built to a higher line of trestle.

The stone was all quarried within 400 feet of the dam, on both sides of the canyon, both above and below the dam. It was hoisted and conveyed to the wall by two cableways, each about 800 feet long and $1\frac{1}{2}$ inches in diameter. The cables crossed the dam nearly at right angles with the chord of the arch, but diverging from each other, and were anchored to convenient trees on either side of the gorge. Their position was seldom changed, except to lift them higher up into the tree-tops, and to erect "A" frames on top of the masonry to support the cables, when the wall had reached such a height as to require it. Loads of 10 tons could be hoisted

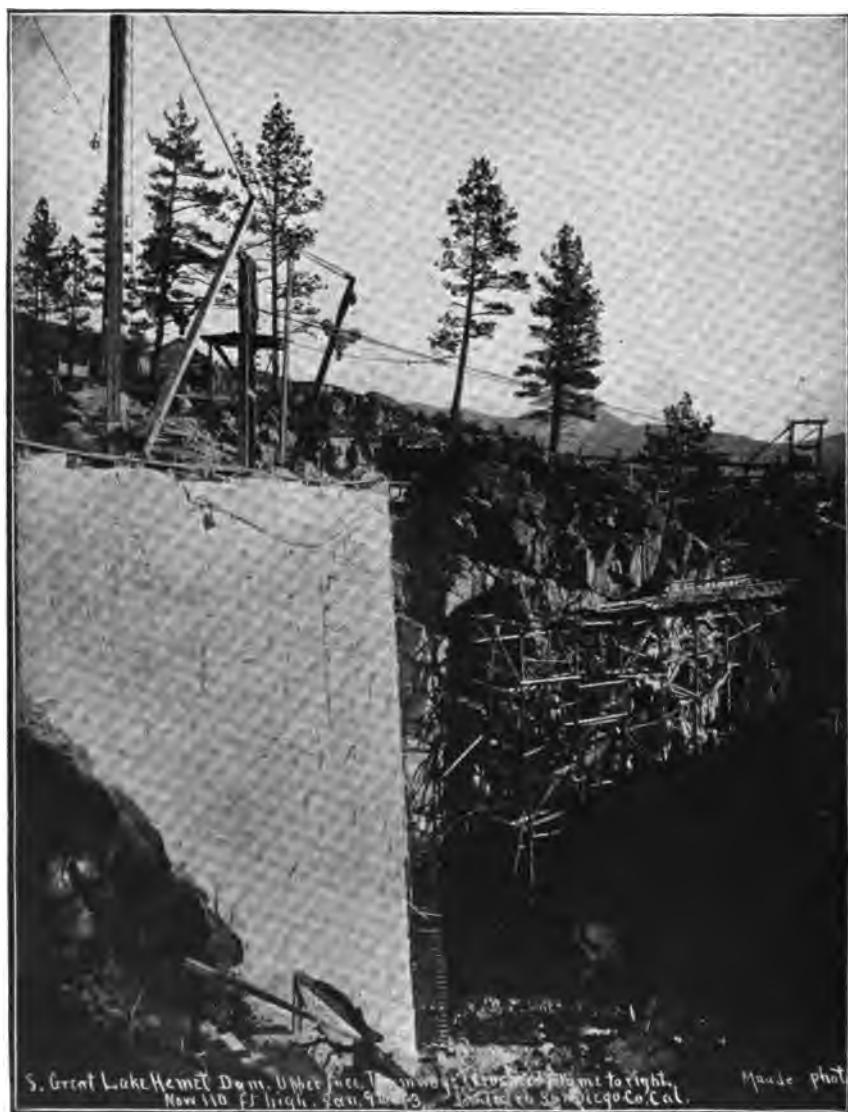
FIG. 171.—LAKE HEMET (CAL.) MASONRY DAM.

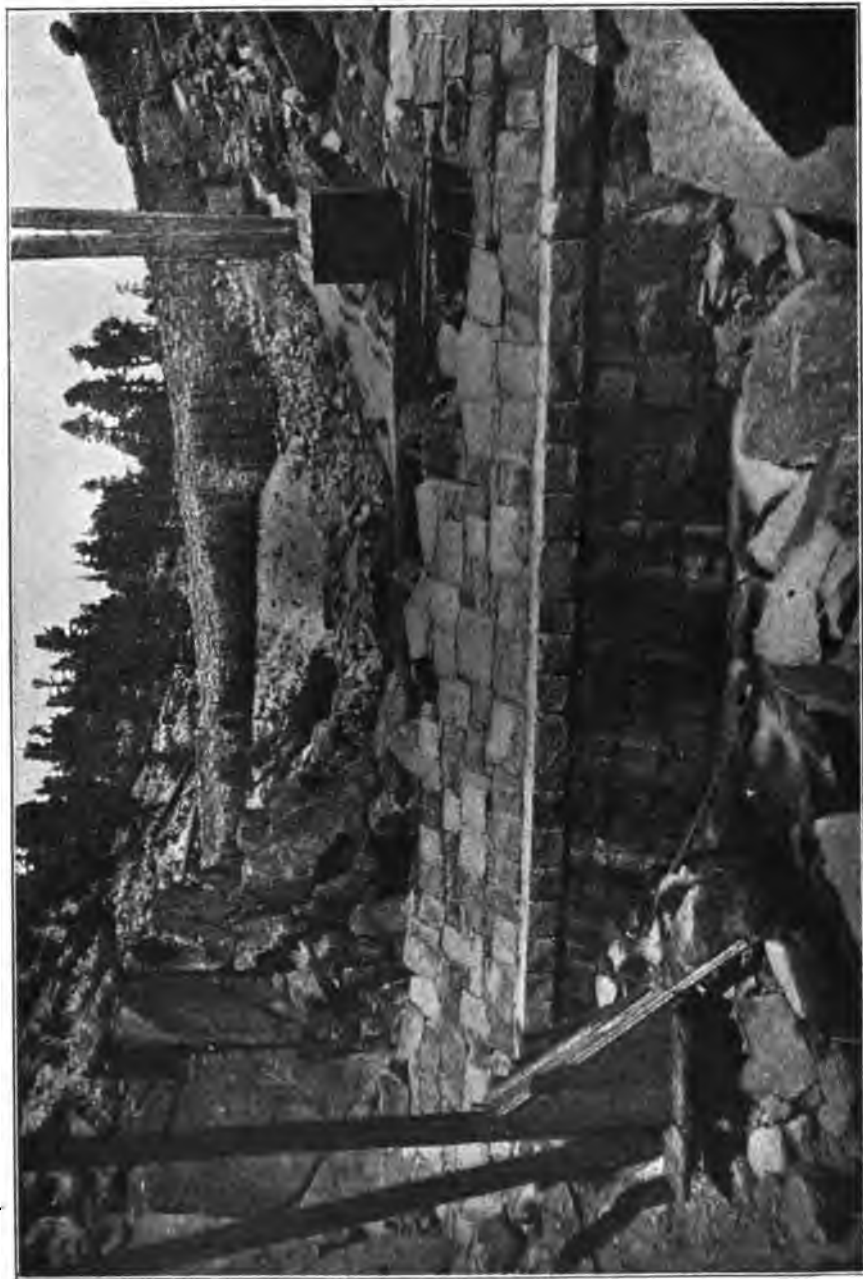
FIG. 176.—BASE OF NEW ROCK-FILL DAM, BELOW THE BEAR VALLEY DAM (SHOWN IN BACKGROUND).

In order to be able to impound the entire run-off from the watershed, or the greater portion of it, the company at one time contemplated the erection of a higher dam, to be built about 200 feet down-stream from the present dam, and impound water to the 75-foot contour of the reservoir, or 11 feet higher than the crest of the existing structure, at which level the capacity of the basin is 80,000 acre-feet, flooding a surface area of 3060 acres to a mean depth of 25.3 feet. It was regarded as impracticable to add another foot to the height of the present dam, and no engineer cared to risk the responsibility of excavating at the toe of the wall for such an addition to it as would enable it to be raised to the desired height; hence it was deemed best to go a safe distance below to avoid jarring or disturbing the fragile wall, and there begin an entirely independent structure. The new dam was designed as a rock-fill, and was to be 80 feet in height above the base of the present dam, but was never finished beyond the foundations, which were laid in a substantial manner in 1893 (Fig. 176). It is a matter of regret that the second dam was not completed, as its completion was recognized as affording a rare opportunity for studying the arch action upon the present masonry wall. At the time it was begun a committee was appointed by the American Society of Civil Engineers to examine and measure the movement in the masonry incident to the loading and unloading of the arch. This could be quickly accomplished by emptying and refilling the pond between the two dams. If taken at the right time, the effect of a flood pouring over the crest of the thin masonry wall could have been observed, and much useful knowledge obtained on the subject of the strains in arched dams of which so little is now known.

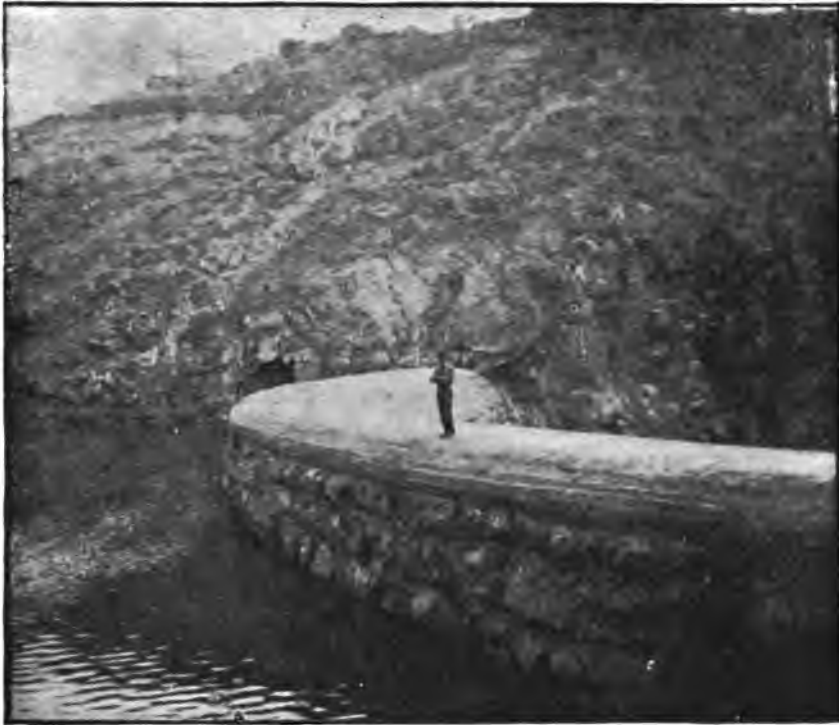
FIG. 180.—UPPER FACE OF LA GRANGE DAM.

The Modesto district covers 81,500 acres, with a main canal 22.75 miles long before reaching the district, having a capacity of 640 second-feet. The entire irrigation system when fully completed will be the largest and most comprehensive one in California, and the dam upon which its success depends has been wisely constructed of such dimensions as to be of unquestionable stability. Figs. 180 to 185 are views of the structure.

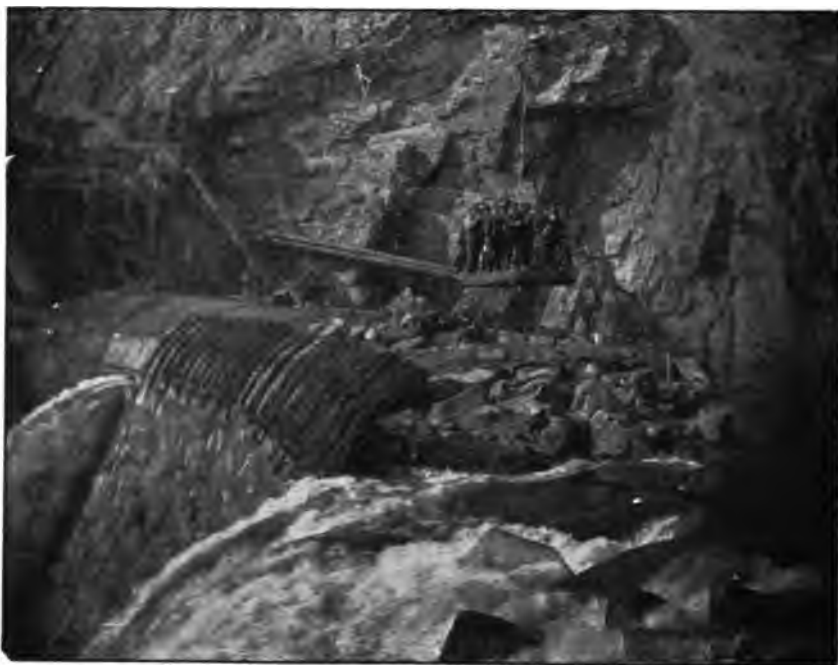
FIG. 181.—LA GRANGE DAM, CALIFORNIA, DURING CONSTRUCTION—FINISHING THE CREST.

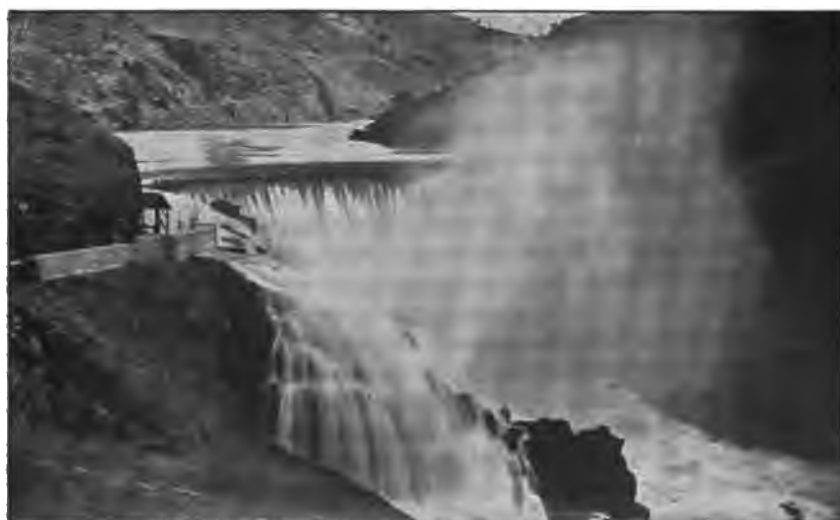
FIG. 184.—LA GRANGE DAM, CALIFORNIA, DURING FLOOD.

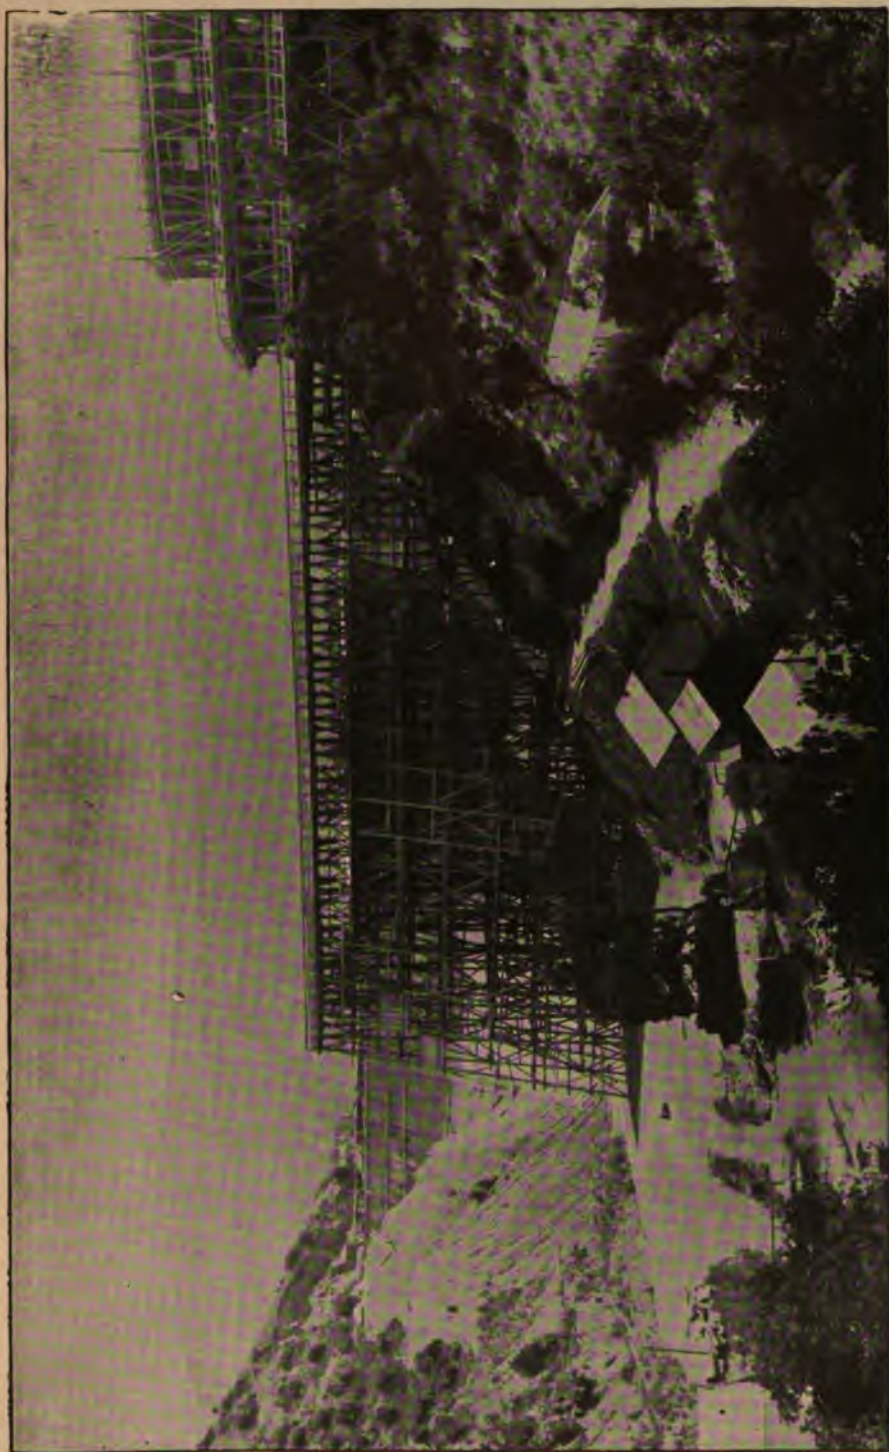
FIG. 190.—PLANT FOR MIXING AND HANDLING CONCRETE AT SAN MATEO DAM.

The concrete was mixed in a battery of 6 cubical iron mixing-machines revolved by steam-power. It was delivered to the work by a double-track tramway on a high trestle carried part way across the canyon at the level of the top of the dam on the lower side, as shown in Fig. 190. The cars on this tramway were pushed by hand and dumped into hoppers let into the floor between the rails, leading to vertical pipes, 16 inches in diameter, which extended down to platforms that were placed from time to time at a level with the top of the work as it progressed. The concrete dropped down these pipes, striking on steel plates, from which it was shoveled into wheelbarrows and trundled to the place of use. The height of this drop was sometimes as great as 120 feet, but no injury resulted to the concrete, or to the men shoveling it as it fell. The concrete was mixed in the proportions of 1 part cement to 2 parts sand, $6\frac{1}{2}$ parts broken stone, and $\frac{3}{4}$ part water by measure. It was moulded in cyclopean blocks of 200 to 300 cubic yards each, with numerous offsets ingeniously dovetailing the blocks together, and every possible precaution was taken in the joining of the successive portions to secure an absolute bond. The surfaces of the blocks after the forms were removed were roughened with picks, swept and washed clean, and grouted with pure cement before concrete was placed against them. The result has been very satisfactory; the dam is almost absolutely water-tight, although some moisture does find its way through and appears in spots on the lower face. No settlement or expansion cracks are visible, and the work has the appearance of being absolutely homogeneous. Figs. 192 and 193 show the general method of forming the blocks and preparing them to receive fresh concrete, and Fig. 194 is a general view of the dam taken at the time of the visit of the American Society of Civil Engineers in Annual Convention, July, 1896. Plans and sections of this dam are shown in Fig. 191. At the 170-foot level the reservoir will have a capacity of 29,000,000,000 gallons, or 89,000 acre-feet. The present capacity is approximately 20,000,000,000 gallons.

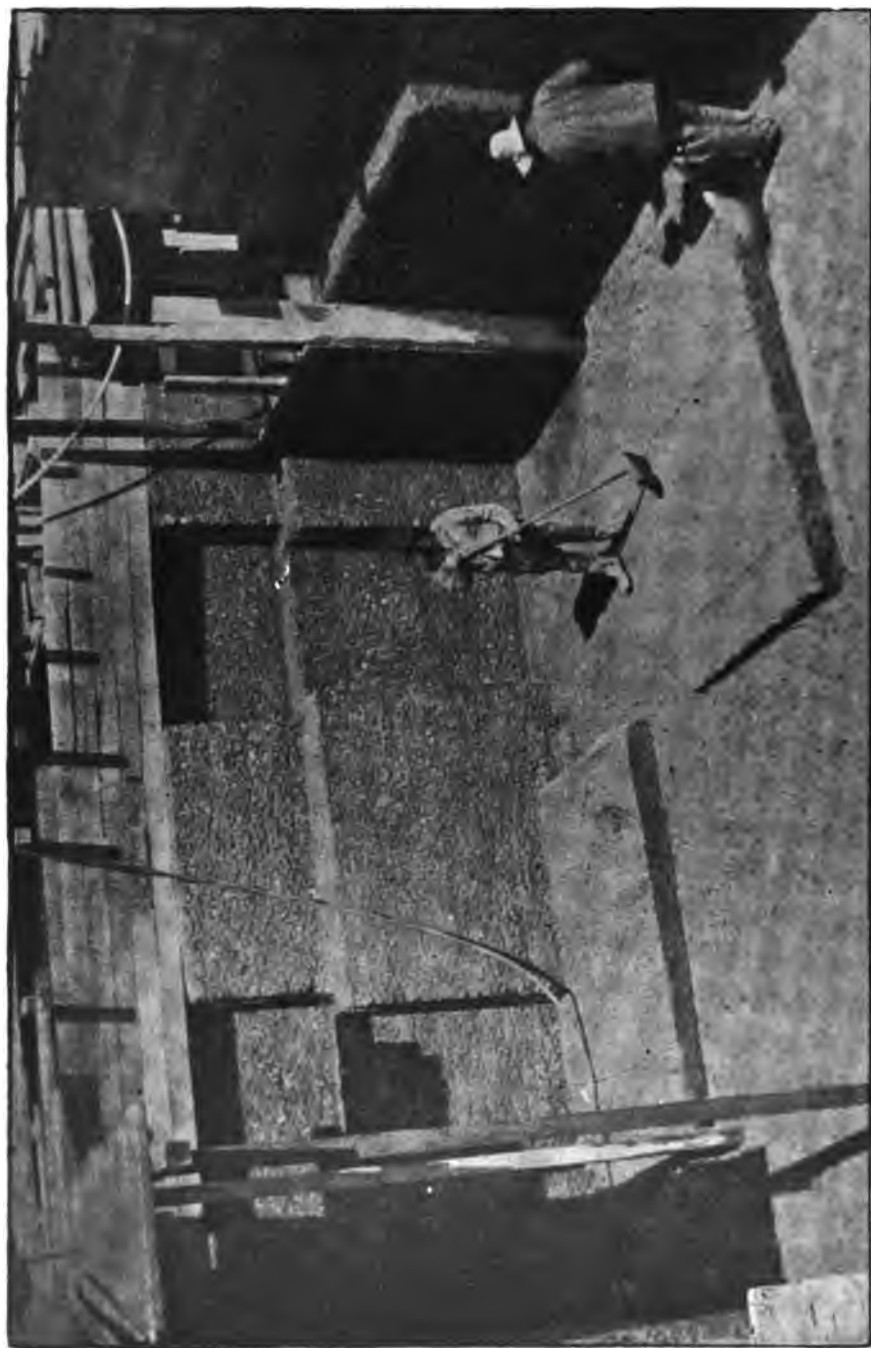
FIG 193.—ROUGHENING SURFACE OF CONCRETE BLOCKS TO RECEIVE FRESH CEMENT, AT SAN MATEO DAM.

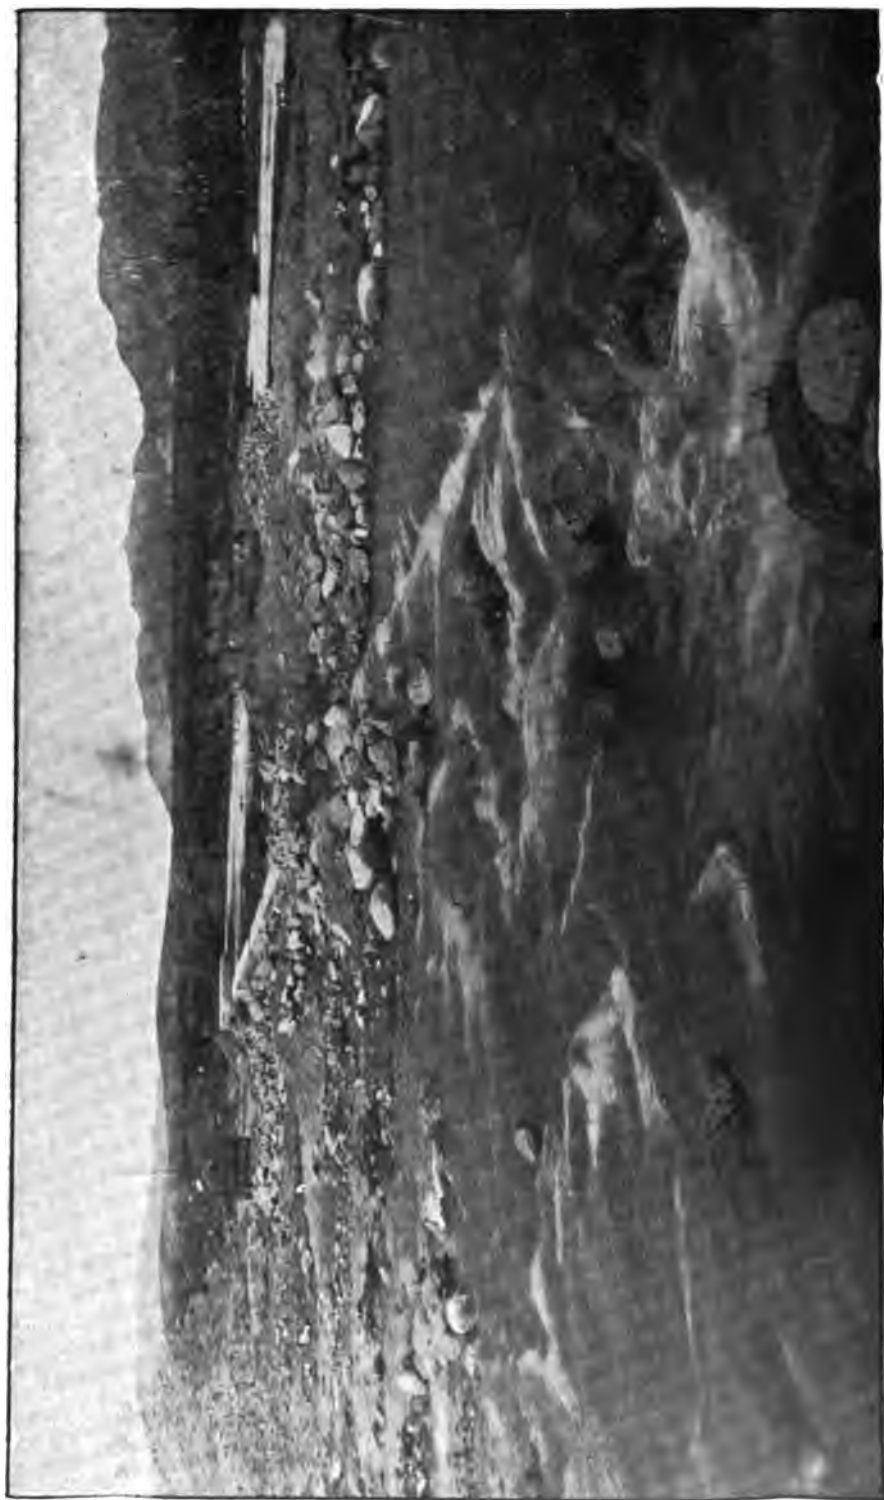
FIG. 197.—VIEW OF FLOOD PASSING OVER PACOIMA SUBTERRANEAN DAM.

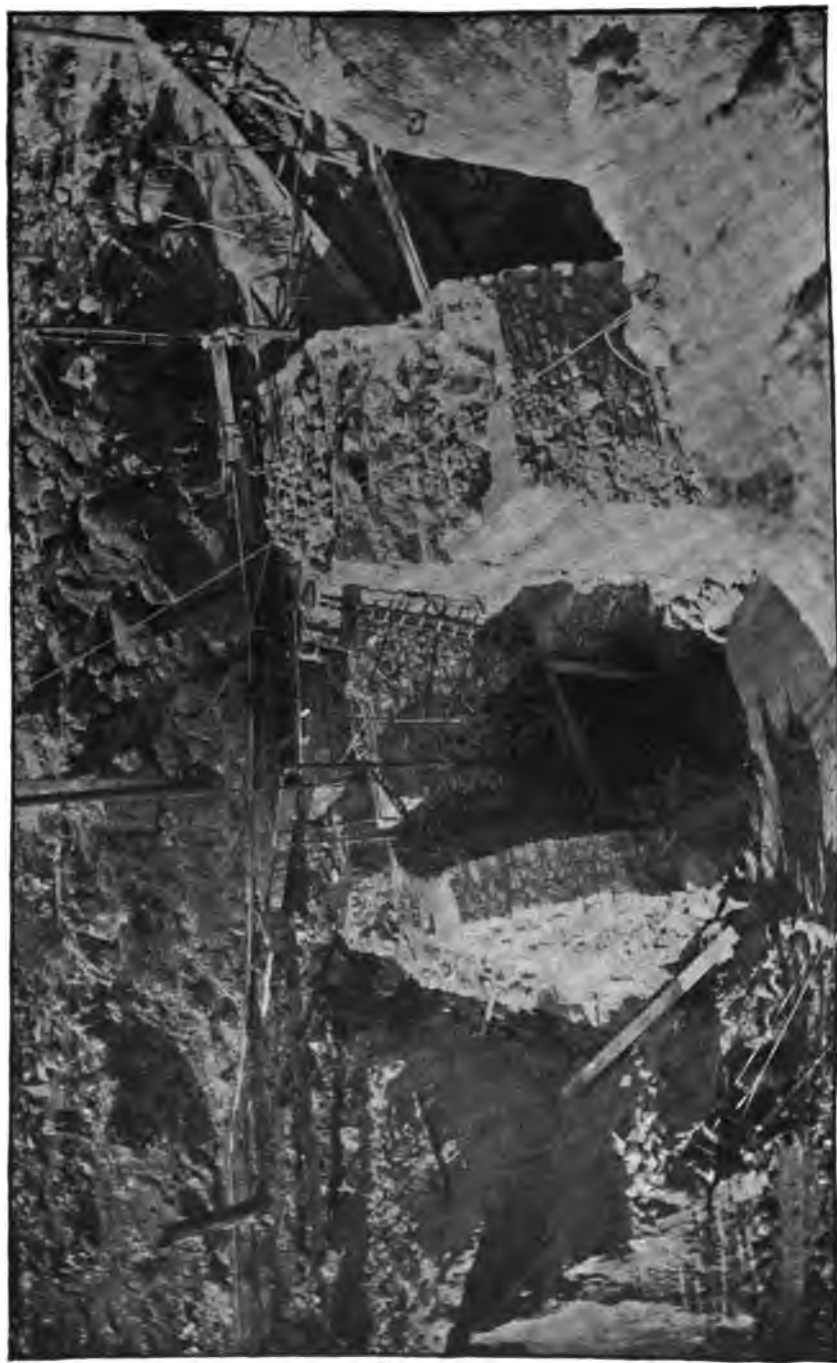
FIG. 200.—FOUNDATIONS OF WEST CHANNEL OF AGUA FRIA DIVERTING-DAM.

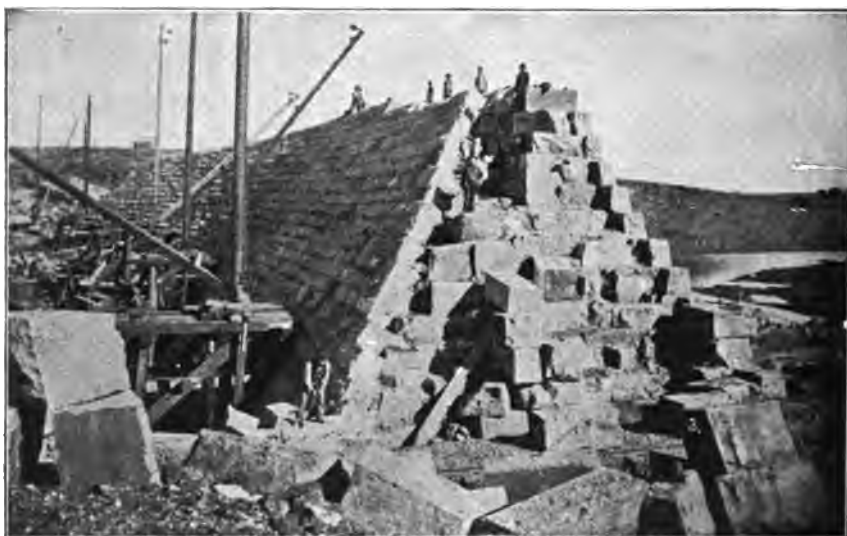
FIG. 204.—SELIGMAN DAM, ARIZONA.

The character of the masonry is well shown by the photograph (Fig. 204) of the lower face during erection. Fig. 205 shows the water-face and end buttresses. The water appearing in the foreground is retained by a low earth dam that had been in use for some time prior to the construction of the masonry dam. The center of the dam is depressed two feet below

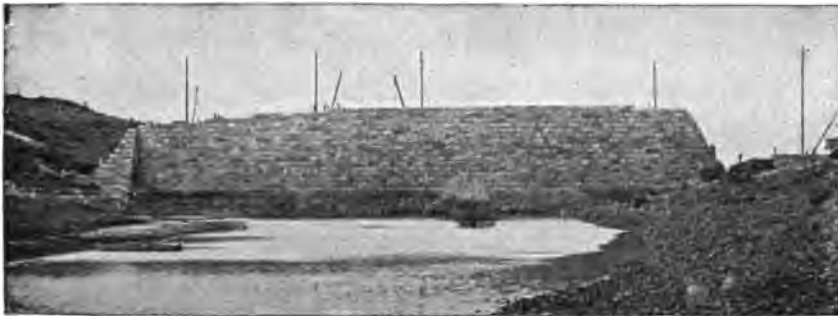
FIG. 205.—SELIGMAN DAM, ARIZONA. VIEW OF UPPER FACE DURING CONSTRUCTION.

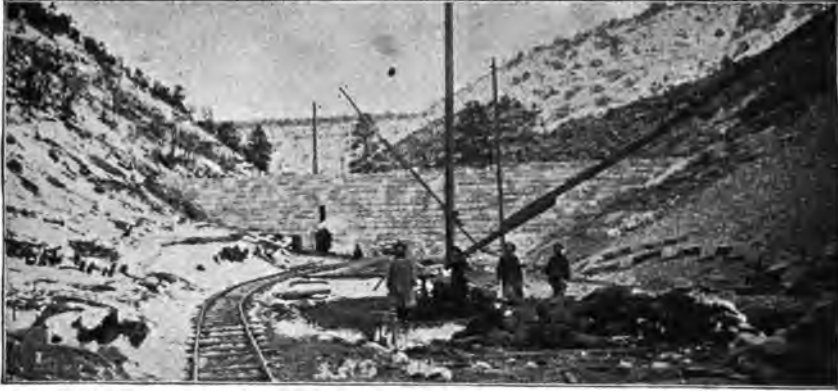
FIG. 207.—WALNUT CANYON DAM, ARIZONA.

Fig. 207 is a view of the dam from below when nearly completed. Fig. 208 shows the profile of the dam as constructed, and a section of the canyon at the dam-site.

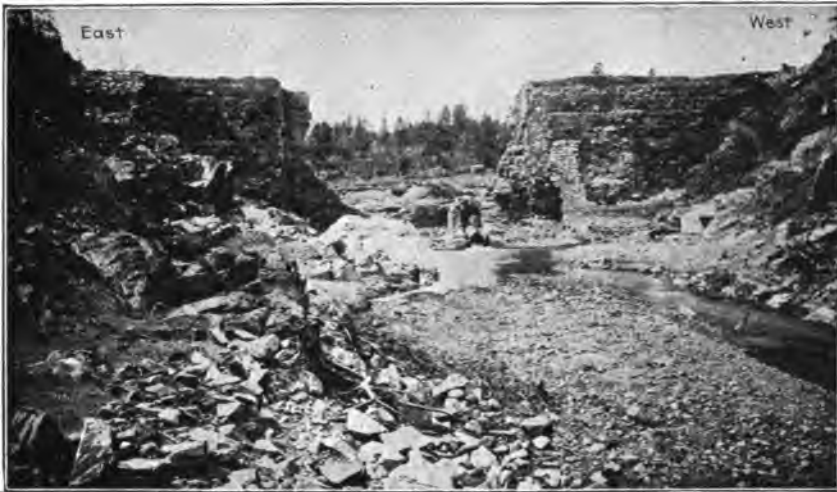
FIG. 209.—LYNX CREEK DAM, ARIZONA, AFTER RUPTURE BY FLOOD. VIEW FROM BELOW.

floods draining the tributary watershed of 30 square miles of territory, from 5500 to 7500 feet in elevation, had the masonry been of reasonably good quality. The failure, therefore, was clearly due to poor workmanship and unsuitable materials. The dam was 150 feet long on crest, and was built with a central angle of about 165° opposed to the direction of the current, the up-stream face being vertical. The wall consisted of a thin facing of hand-laid masonry, not over one foot thick, the core being filled with a weak concrete of fine gravel, stone, spawls, and sand. The section of the dam as constructed is clearly seen from the photograph (Fig. 210). Considerable lime was used with the cement, which was of poor quality, and the concrete, though ten years old, possesses so little cohesion that it may be crumbled with a light touch. The cement used averaged but 1 barrel to 6 cubic yards of masonry. The failure of the dam, under all the circumstances, might have been anticipated. It is referred to here merely as an example to illustrate the natural consequences that must follow any carelessness or lack of attention to proper selection of materials and skill of construction in masonry or concrete dams that must withstand the erosive action of floods as well as normal water-pressure.

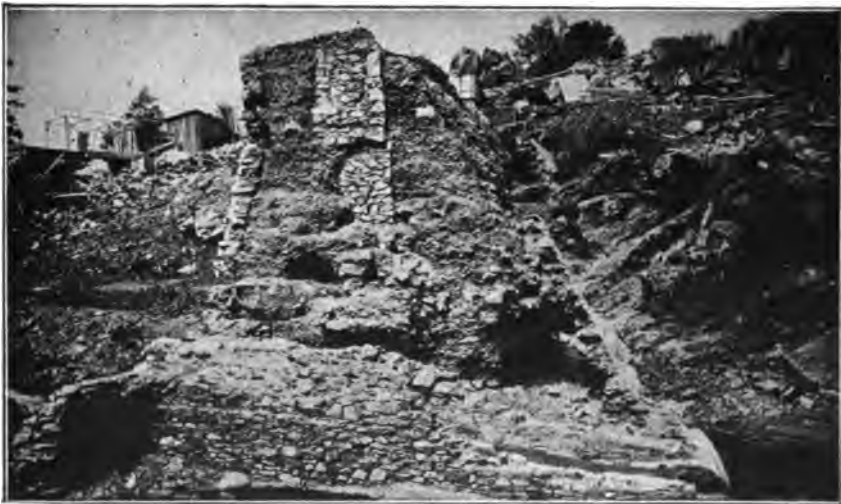
FIG. 210 —LYNX CREEK DAM, ARIZONA. SECTION SHOWING FACING WALLS AND CONCRETE HEARTING.

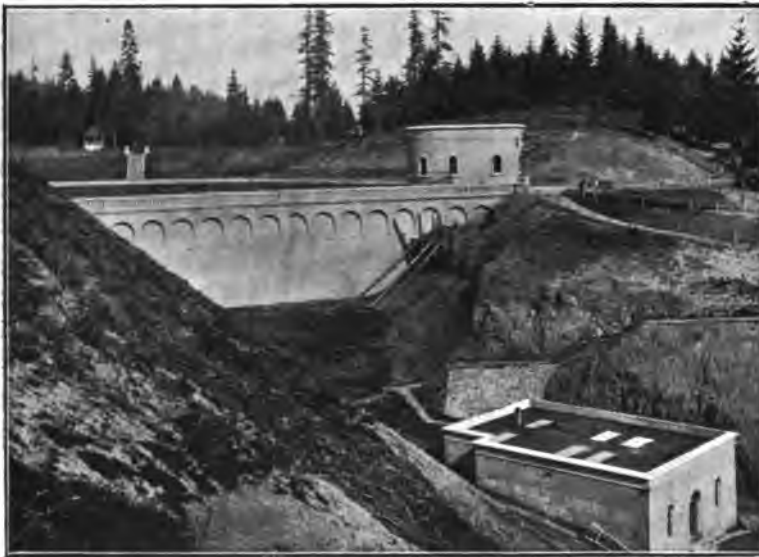
FIG. 212.—CONCRETE DAM, 60 FEET HIGH, AT RESERVOIR NO. 3, PORTLAND, ORE. POWER-HOUSE IN FOREGROUND.

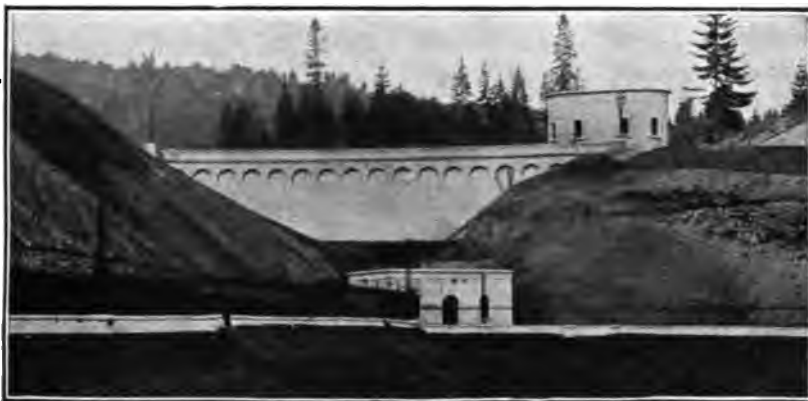
FIG. 214.—CONCRETE DAM AT RESERVOIR No. 3, PORTLAND, OREGON, WATERWORKS, SHOWING POWER-HOUSE BELOW.

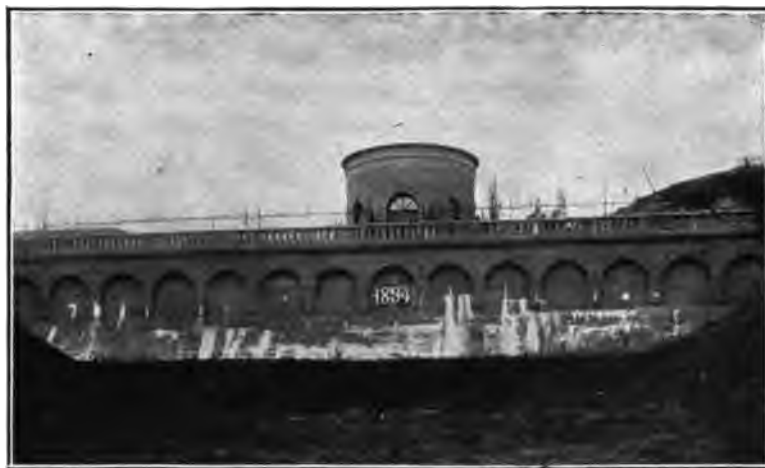
FIG. 215.—CONCRETE DAM OF RESERVOIR No. 4, PORTLAND, OREGON., WATERWORKS.

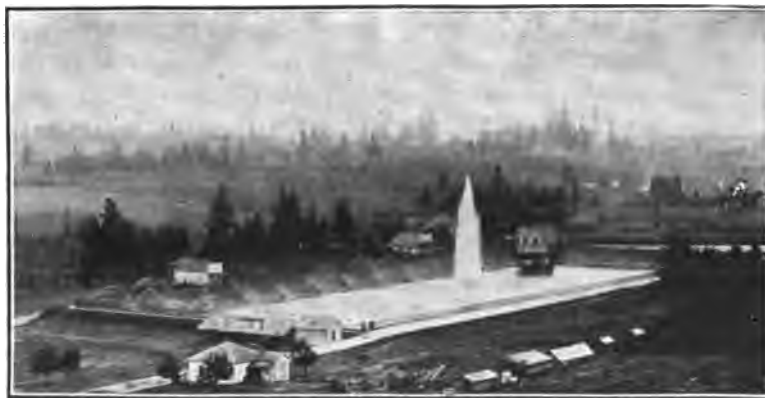
FIG. 216.—RESERVOIR No. 2, PORTLAND, OREGON, WATERWORKS, SHOWING AERATION FOUNTAINS.

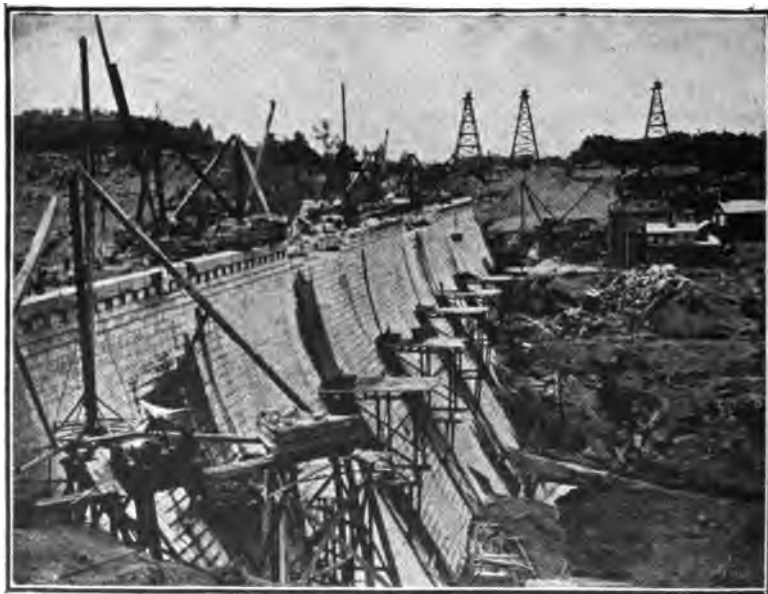
FIG. 220.—THE CROSS RIVER DAM FOR NEW YORK CITY WATER SUPPLY.

The Cross River Dam, New York (Figs. 219 and 220).—The Aqueduct Commission of New York City have under construction and practically completed a high masonry dam for storage of water on Cross River, a branch of the Croton River, near Katonah, N. Y., to the extent of a total capacity of 9,000,000,000 gallons (27,540 acre-feet) at a cost under the contract awarded to MacArthur Bros. Company and Winston & Co. of \$1,246,211.60.

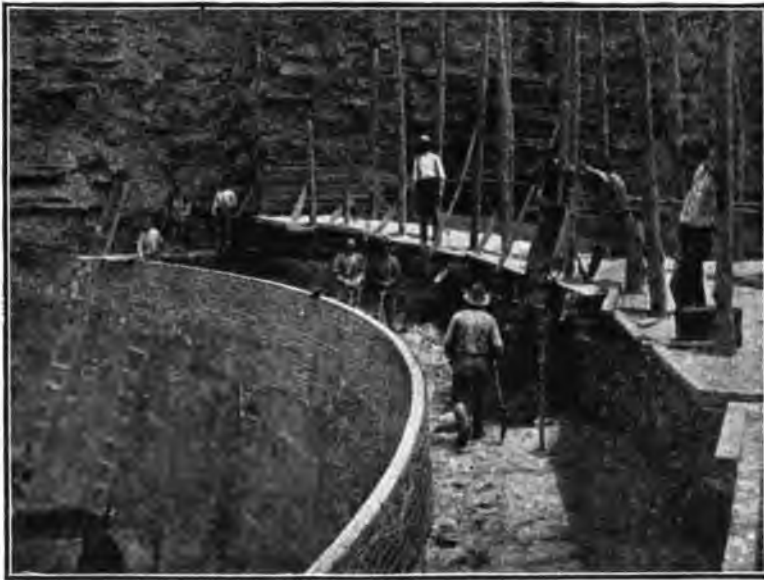
FIG. 222.—ITHACA DAM, NEW YORK, ILLUSTRATING CONCRETE CONSTRUCTION BETWEEN BRICK-FACING FORMS.

The Ithaca Dam, New York (Figs. 222 and 223).—One of the curiosities of recent dam construction is situated two miles from the city of Ithaca, on Six-Mile Creek, in a narrow rock gorge, with vertical walls but 90 feet apart. The dam was designed by Prof. Gardner S. Williams, M. Am. Soc. C. E., of Cornell University, who was inspired by the narrowness of the site to attempt a structure of most unusual slenderness and peculiar form.

base, and finished off with an up-stream batter of 45° and a top thickness of 1 foot. The maximum thickness is 7.75 feet. The dam is composed of concrete, mixed in the proportion of 1 part cement, 2 parts sand, 2 parts gravel, and 2 parts broken stone, crushed to pass a 4-inch ring. The concrete was placed between thin walls of vitrified paving-brick, laid in a single course on each face, in cement mortar anchored into the body of the concrete by flat steel bolts, $1\frac{1}{2} \times \frac{1}{4} \times 7$ inches, turned up $\frac{1}{2}$ inch at each end and placed at every fifth brick in every fifth course.

Inside the brick facings is a layer of rich cement mortar, 3 inches thick, in which are imbedded bands of steel, 3 inches wide, $\frac{3}{8}$ inch thick, placed 4 feet apart, extending entirely around the structure, and tied through the dam every 4 feet by $\frac{1}{2}$ -inch steel rods, having a nut on each side of the bands. Over the steel frame thus formed is a wire netting with 4-inch mesh imbedded in the mortar.

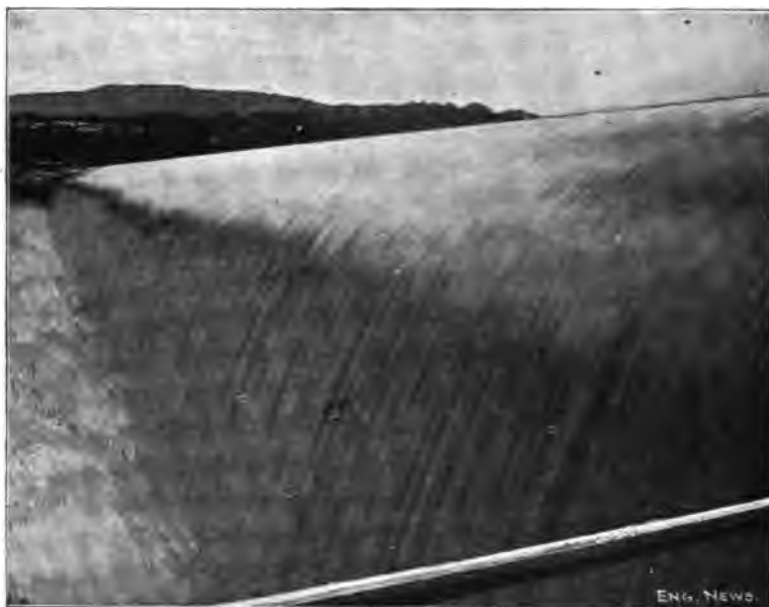
FIG. 229.—AUSTIN DAM DURING FLOOD OF APRIL 7, 1900, AND IMMEDIATELY BEFORE THE BREAK.

The appearance of the dam immediately before the break is shown in Fig. 229. Figs. 230 and 231 graphically present the break and the bodily movement of a section of the dam down-stream intact, better than any detailed description. The author is indebted to *Engineering News* for these three cuts.

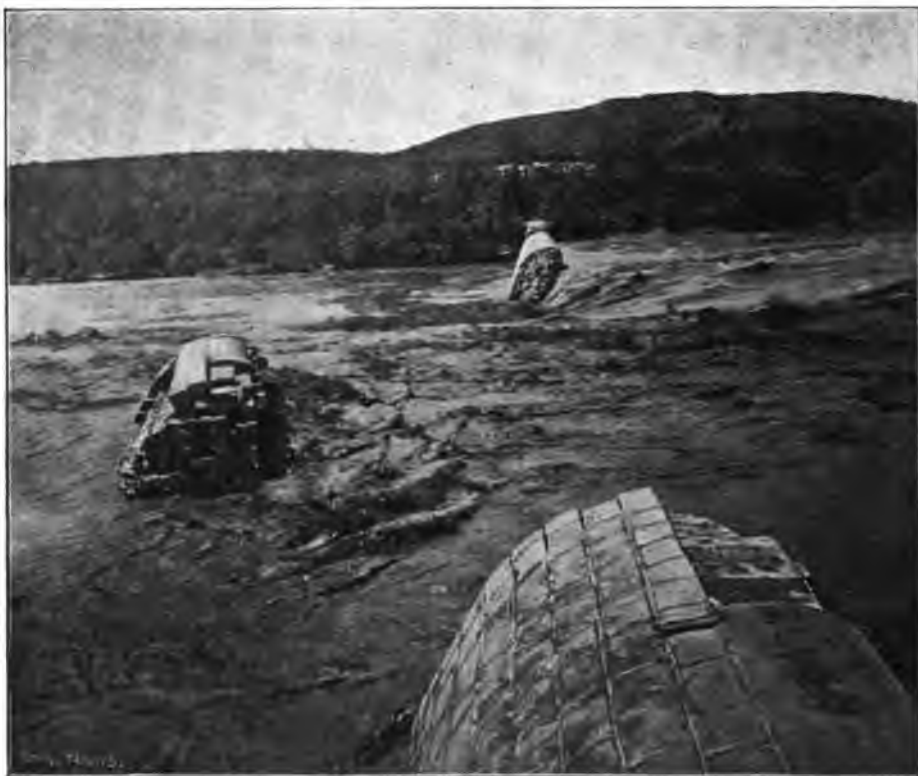
FIG. 230.—AUSTIN DAM, TEXAS. VIEW TAKEN DURING FLOOD, A FEW MINUTES AFTER THE BREAK

Failure of the Austin Dam.—On the 7th of April, 1900, a severe flood in the Colorado River and its tributaries, unprecedented since the erection of the dam, resulted in the failure of this fine structure, with considerable loss of life. About 500 feet of the masonry was first pushed bodily downstream, about 60 feet, apparently sliding on its base, and after a few hours was entirely broken up and washed away, with the exception of a small section, which still stands upright in the position where it was first de-
